Local Oscillator Drift LNB Replacement

Effective: April 17, 2007

(Replaces Business Rule of same title dated January 8, 2007)

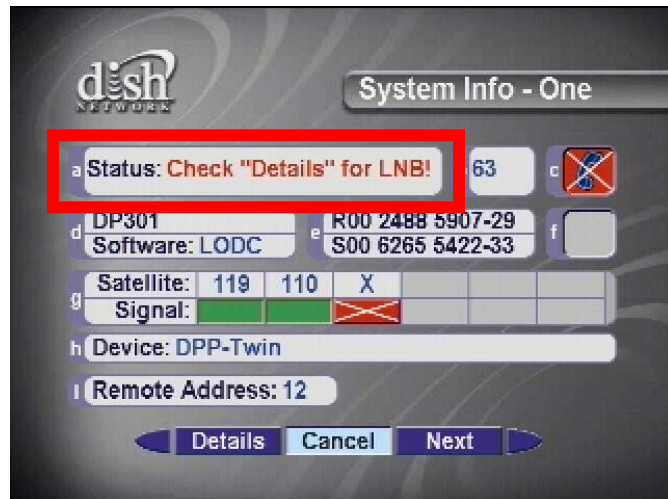
After entering System Info on a Super Diagnostics supported receiver, an automatic signal scan is run and its status appears in Field A.

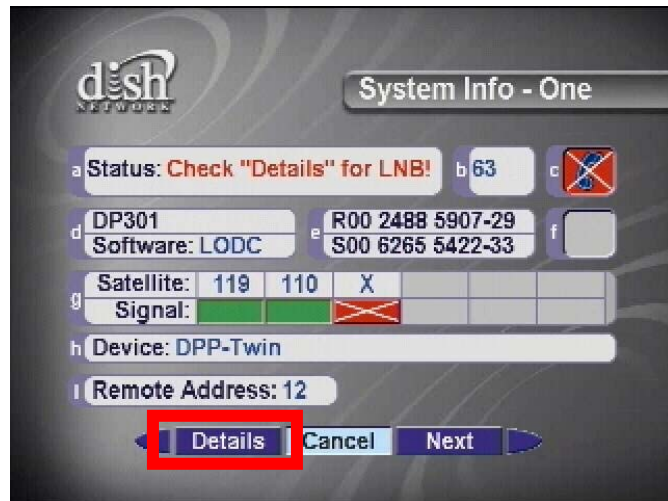
If this Field's Status says "**Check 'Details' for LNB!**", select the onscreen "**Details**" button to view the details of the signal scan.

NOTE: If the Status field says "**GOOD**" then the LNBF is functioning properly and no further actions are required.

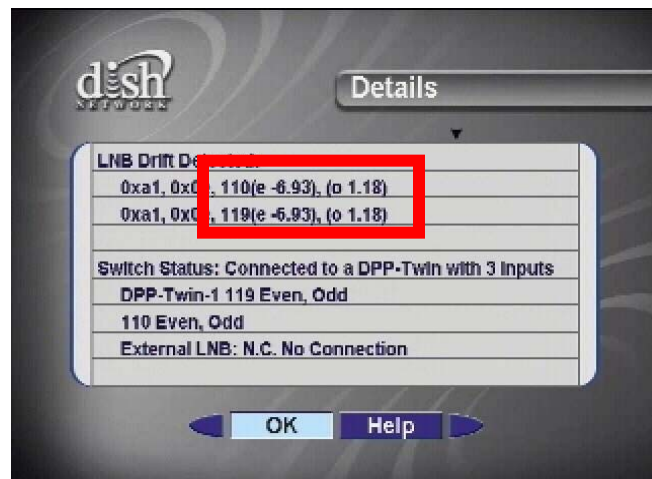
Once in the "Details" screen the LNB LO drift values will be listed.

If any of the LNB Drift values are equal to or greater than ± 5.00 , **REPLACE** the LNBF to prevent a possible future Trouble Call.

NOTE: If the LNB Drift is greater than ± 12.00 MHz, and the system is functioning properly, this may indicate a false reading and should be ignored. NO LNB REPLACEMENT IS REQUIRED.

Once the LNBF has been replaced the technician should verify the operation of the newly installed LNBF by rechecking for LO Drift in the System Information screen.
