# Important Glorystar Switch Notice:

Our records indicate that you have recently purchased a Glorystar Christian Satellite System, which may contain an incorrectly labeled switch.

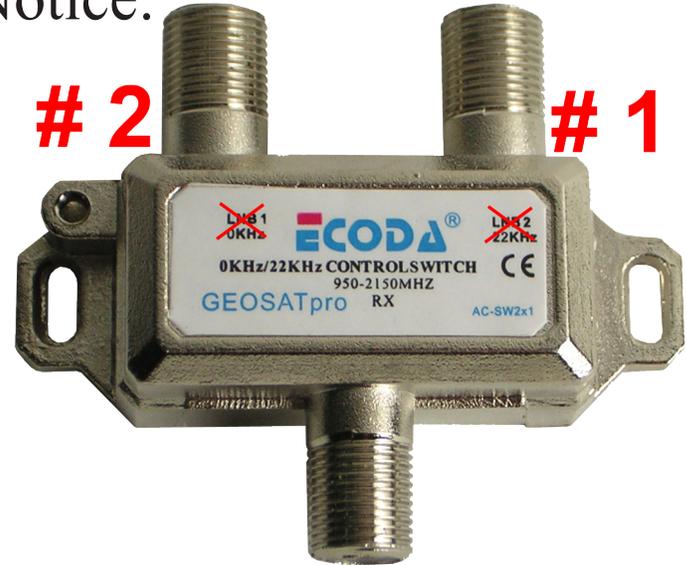
Due to manufacturing error the Ecodas 2x1 switch input ports are incorrectly labeled and will not properly switch between satellites when installed according to the Installation Guide.

To correct this error, simply reverse the coax cables connecting the LNBFs to the Switch.

Connect **LNBF #1** to Switch port **LNB 2 / 22KHz**

Connect **LNBF #2** to Switch port **LNB 1 / 0KHz**

Do not install the switch. Assemble the dish with only one LNBF and connect directly to the satellite receiver without the 2x1 switch. This one LNBF solution will only result in the loss of three Glorystar channels:
