TECHNICAL INFORMATION BULLETIN

Subject: Handling Precautions during Installation

Products Affected: DISH 500+ and DISH 1000+ LNBF Assemblies

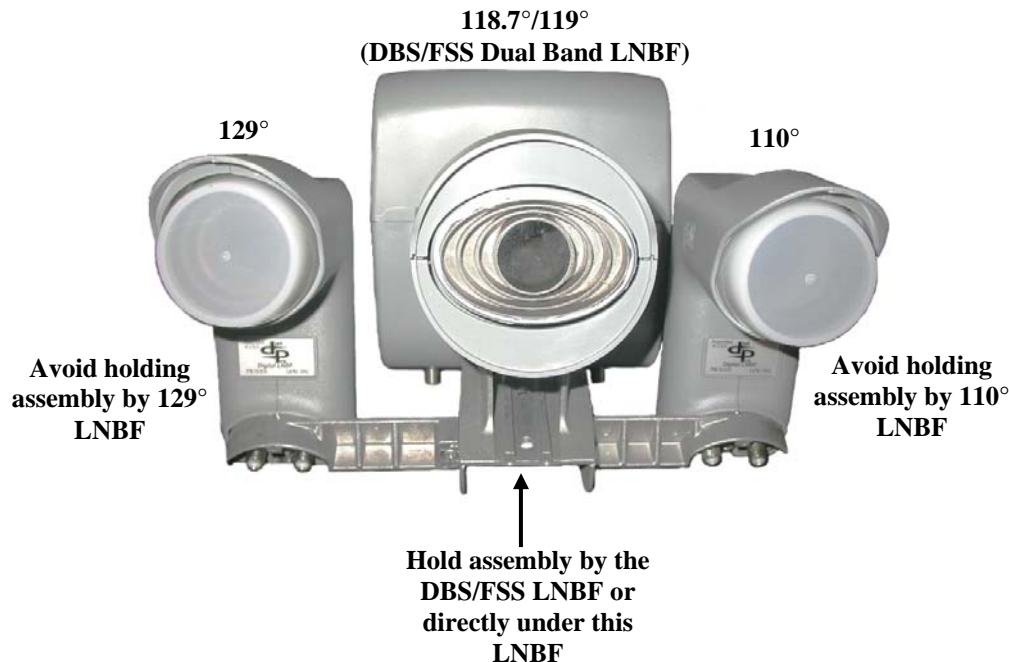
The LNBF bracket assembly for early production quantities of the DISH 500+ and DISH 1000+ should be handled carefully during installation. This will prevent damage to the side brackets that attach the 110° and 129° LNBFs to the center 118.7/119 DBS/FSS LNBF. Follow the handling tips below to avoid bracket damage during installation. The LNBF mounting brackets are otherwise rugged enough to withstand antenna operational loads once installed and shipping loads in their original packaging.

- Handle the LNBF assembly by the DBS/FSS Dual Band LNBF or by the bracket directly under this LNBF. Avoid handling the LNBF assembly by the outer 110° or 129° LNBFs. See figure below.

- Avoid dropping or hitting the LNBF assembly against other objects.
- Use original packaging where possible when transporting the LNBF assemblies. For added protection during shipment, detach the 110° and 129° LNBFs from the bracket.

Improved LNBF assembly brackets are currently in production to improve resistance to handling damage.
